BALTIMORE METROCENTER SURVEY

SURVEY NO.: B-2018

Address: 18-20 East Franklin Street

INVENTORY FORM FOR STATE HISTORIC SITES SURVEY

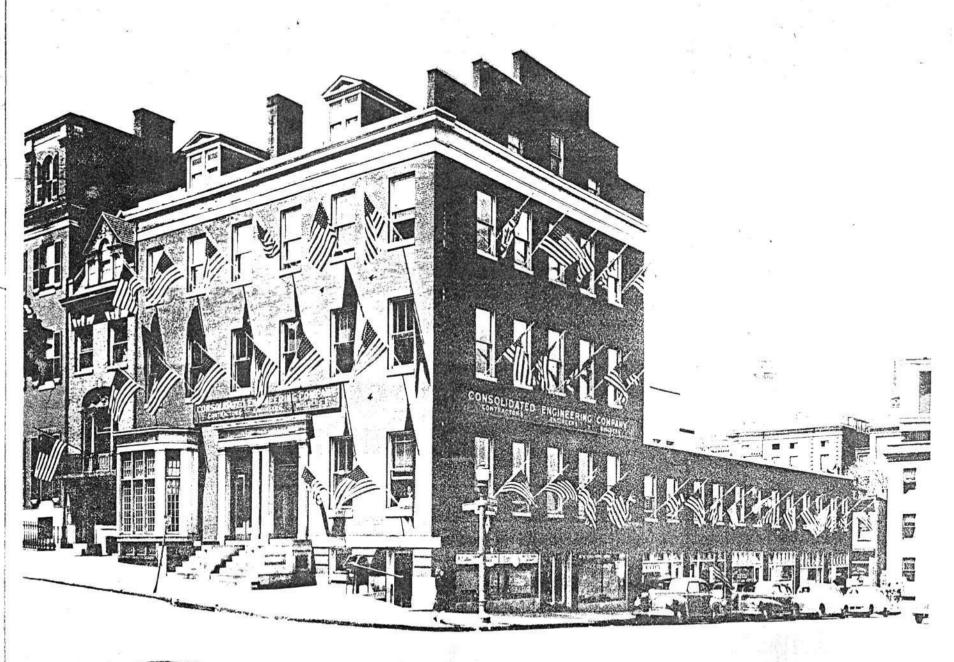
MC 6790

18-20 East Franklin Street B-2018 Photo ca. 1945, Peale Museum

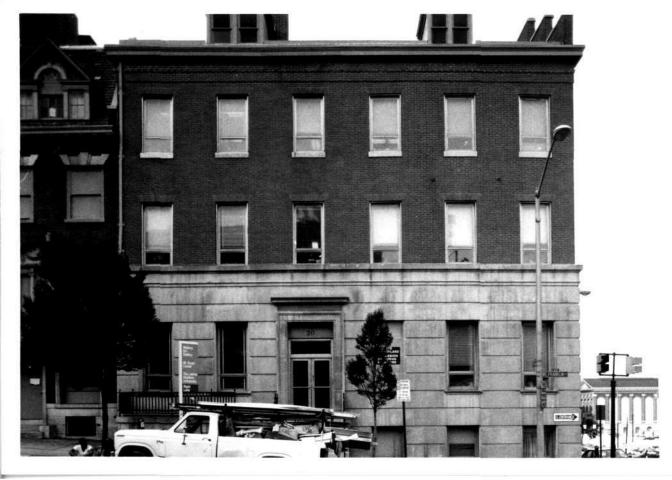
South elevation

Description: The original townhouses were united by a rusticated concrete facing on the first story and basement in the mid 20th century. The plain pilasters and single entablature of the doorways were replaced by a single modern glass and aluminum door; the other door became a blind window bay. Above the concrete facing, the six bays of the two houses are still intact, with gauged jack arches and modern plate glass windows. The common bond exterior brick may be a replacement of the original flemish bond. The cornice is relatively narrow, with two projecting brick courses below. The gable roof has a pedimented dormer with paired windows in each. The east elevation features a stepped gable. The addition of several windows in a five-bay regular pattern is an alteration of the early 20th century. A two-story rear addition facing St. Paul Place contains storefronts now used as offices by the Human Relations Commission.

18-20 East Franklin Street B-2018
Cathedral Hill - Metrocenter Survey
Baltimore (City), Maryland
Photo: Janet Davis
Date: July 1984
Neg. loc.: Maryland Historical Trust
